Manhole Inspection Summary

Manhole # S31E__017MH

Insp Date: **8/11/08 9:46 AM**

Location Address: **130 n paca st**

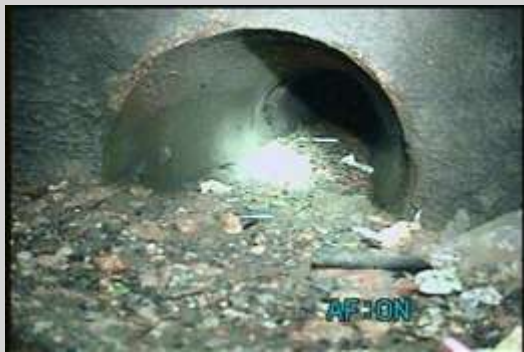
12 O'Clock Outflow

8 in. Circular Gravity Sewer
Pipe Out @ 12 O'Clock

Pipe Material: **Clay** ☐ Pipe Lined

Infiltration: **None** Pipe Seal Cond: **Unknown**
